FW: 70 PT-19 Fuselage Stringer Problem
1 message

Fairchild PT-19 Military Trainer

November 10, 2012

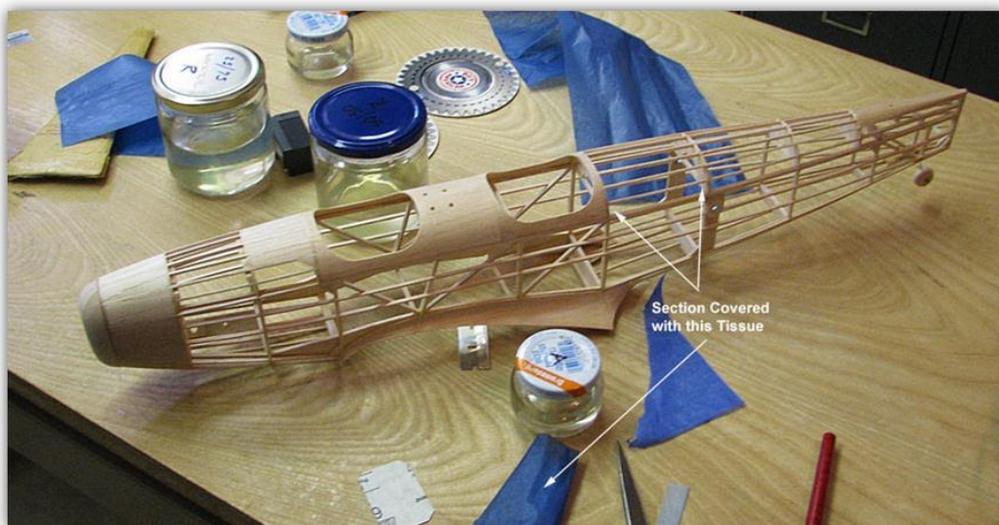
My day started off trying to cover the fuselage with blue tissue. I had gotten a lot of feedback on how quickly the blue Esaki Japanese tissue would fade, but that it was lighter, easier to work with, and stronger than the domestic tissue that came in the Easy Built kit. However, the domestic tissue would retain its color better and for some time. So my first attempt was to cover the section behind the second cockpit opening with the domestic tissue. Because of the tapering stringer structure, I had to moisten the tissue to get it to conform. Well, it started pulled apart like wet Kleenex! :O< I could see that this domestic tissue was not going to work for me, so I switched to the Esaki Japanese tissue. I was able to successfully cover the section behind the second cockpit opening, shrink it down with alcohol, and put on one coat of 25/75 clear dope. After this dried, I was going to cover the next two sections behind that one when I noticed a stringer unsightly problem. All five of the 1/16" X 1/8" stringers were noticeably sagging between the two bulkheads with only one coat of dope on the tissue. &##\$ I quickly put Acetone on the tissue and was able to remove it as shown below.

The obvious problem is that the stringers too weak to support the doped tissue, which just about made me sick. What needs to be done is the weak /16" X 1/8" stringers need to be carefully cut out and removed from all of the bulkheads. Then larger deeper stringers like 1/16" X 3/16" or even 1/16" X 1/4" used as replacements. I think the 1/16" X 1/8" stringers on the sides and up front are OK, but the five on top behind the second cockpit and the five on bottom all need to be replaced.
