TANDY WALKER'S 2nd A CLASS BOMBER-30 to 40

FW: 30 Class A Bomber Silked Vertical Tail

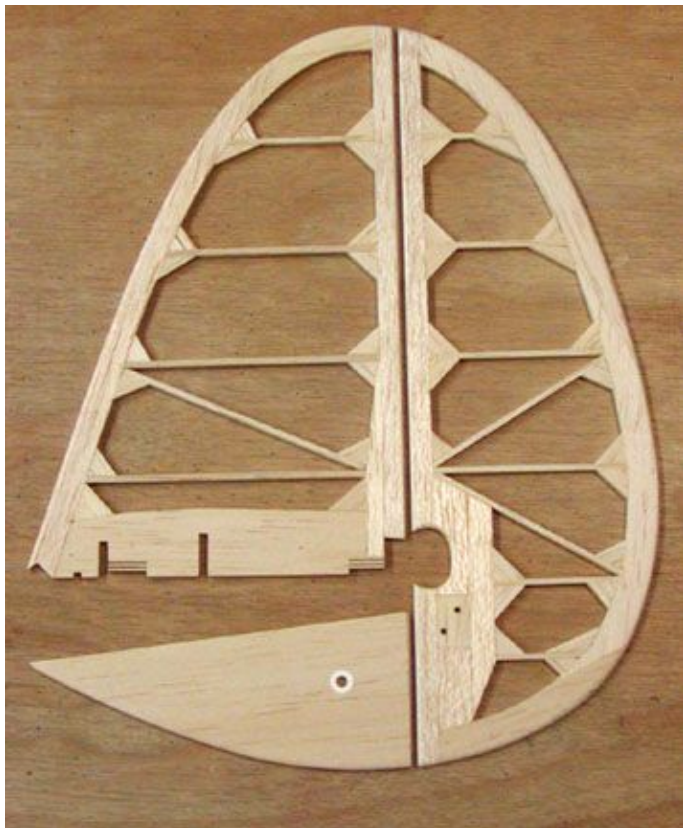
Silked Tail 2.jpg

The two pictures below shows the three vertical tail components before and after the first layer of silk covering has been applied. They have been water shrunk , but not doped yet. I finished covering them Saturday morning, but have been incapacitated ever since. I have never had back problems before, I must have developed what I think may be a pinched nerve because I have been in bed since Saturday afternoon. I am taking aspirin and using a hot pad, but I can't seem to get any relief from pain. Hopefully, this problem will resolve itself sometime this week.....Tandy

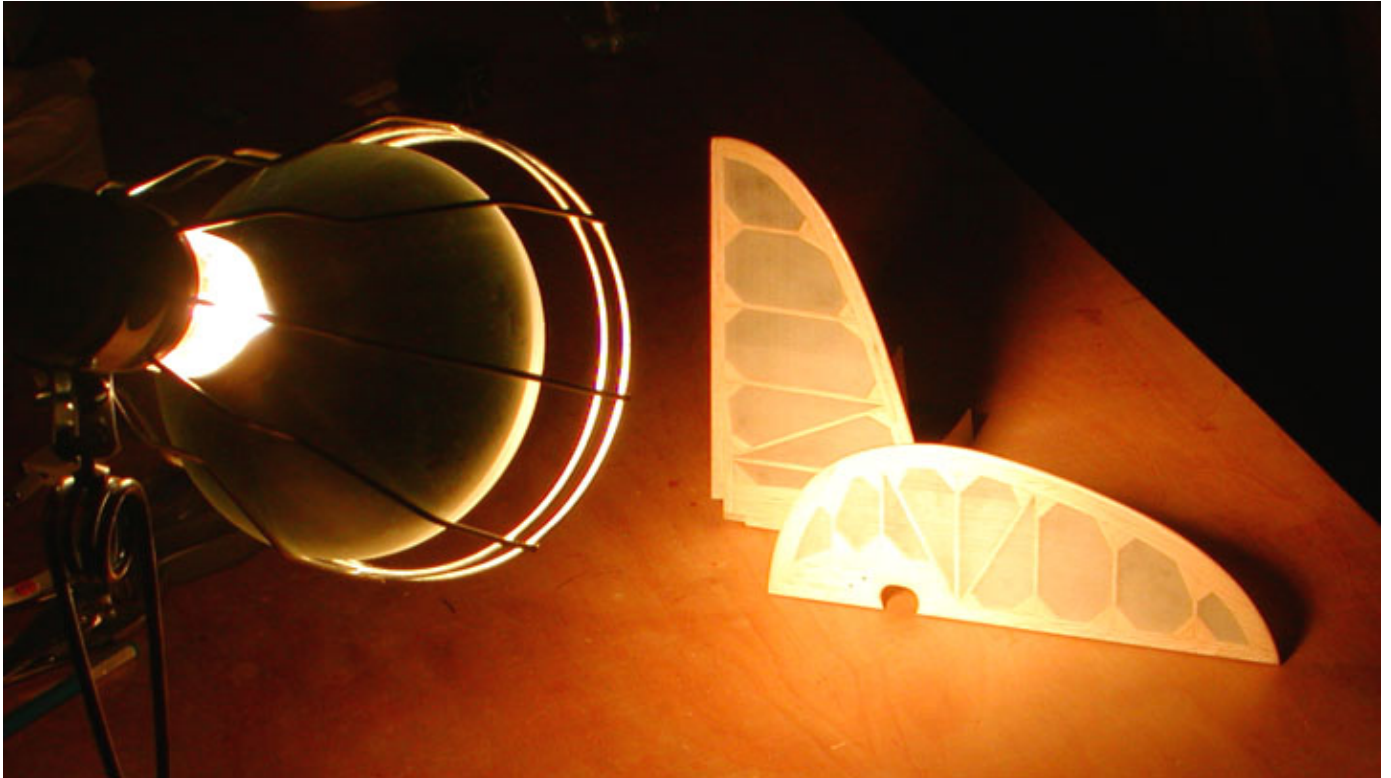
Doping.jpg

It started raining here a couple of days ago and it is still raining. I started doping the rudder and fin, but even though the dope was drying to the touch, the silk remained slightly wrinkled due to the coolness and dampness. So I am using a low power heat lamp to dry the dope and shrink the silk taunt between coats. The picture below shows the third coat of dope curing in front of the heat lamp. I set a timer for 15 minutes per side and it is working out pretty

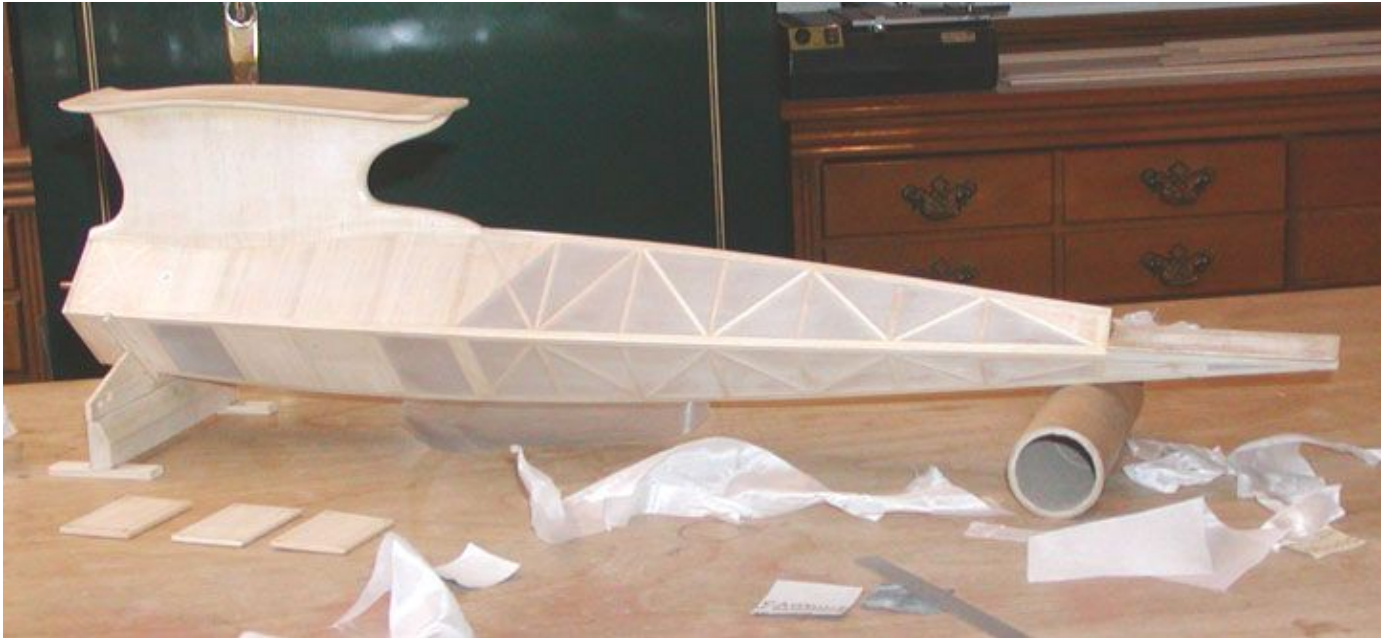
Silked Fuselage 1.jpg

I finished applying the first silk covering to the fuselage and have brushed on the first critical coat of nitrate dope. Critical because of the care that must be taken to prevent the dope from globbing up under the raw silk. The silk covering is quite taunt and bonded well in the fillet areas as the the three pictures below show. Today I will apply a couple more coats of dope and then cut out the silk in all of the screw and hatch openings (*speaking of hatches, note the three silked covered access hatches in the foreground of the first picture*).

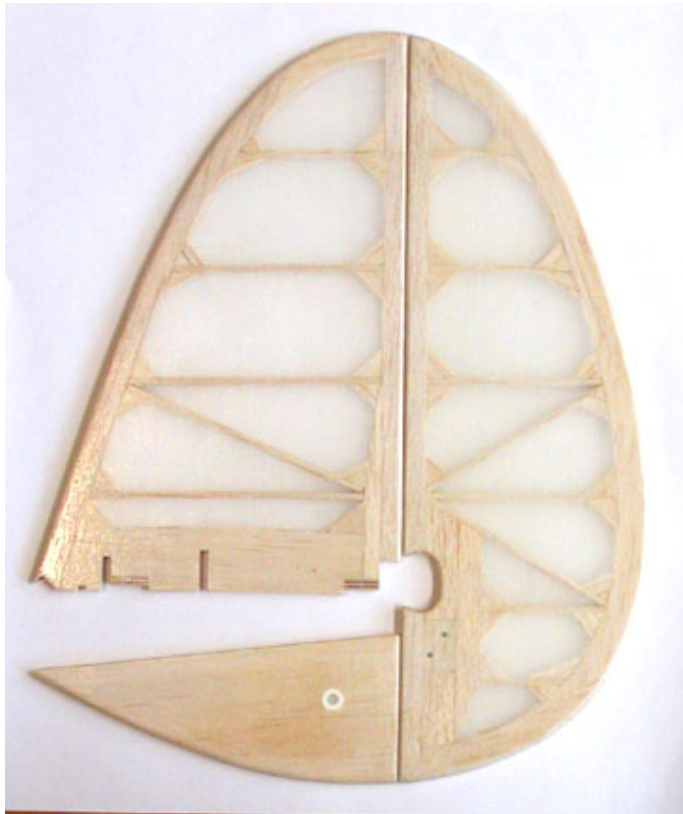
Double Silk 1.jpg

I have started double silking the Class A Bomber fuselage and vertical tail. First I did the three access hatches. Then after applying the second coat of silk and two coats of nitrate dope on the rudder and sub rudder, but not the fin, I decided to take a picture for comparison. Below, is a picture of the three components of the vertical tail. The rudder and

sub rudder have two silk coverings and fin has only one.....Tandy

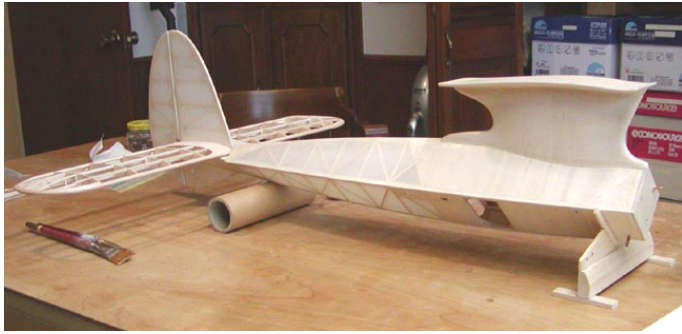
Double Silked 3.jpg

I have finally finished the second silk covering on the fuselage, fin, rudder, and sub rudder of the Class A Bomber as shown in the first picture below. Don't let anybody kid you, the second silk covering is more difficult than the first to get on with the grain straight and no bubbles between the two layers. I have put two coats of nitrate dope on the second silk covering so far.

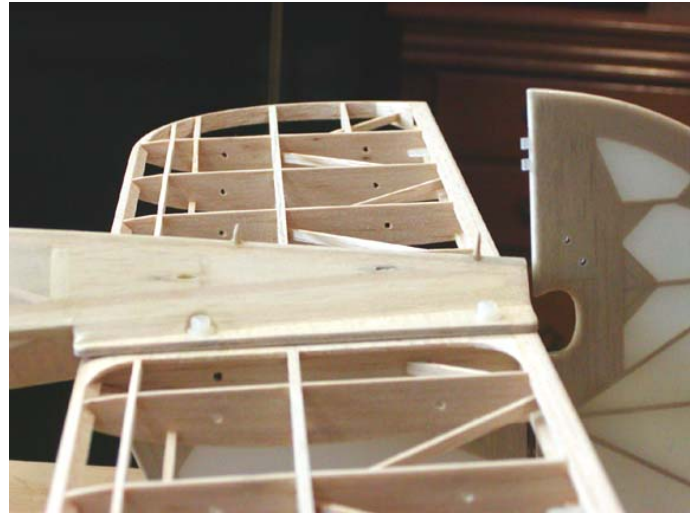
Sub Rudder Pins.jpg

The second picture shows the two centering pins used to alignment the sub rudder along the bottom edge of the longeron on the fuselage. The third picture shows the sub rudder installation. Notice that the fin and rudder have been clamped to align the rudder to the fin. The the sub rudder is epoxied in place over the centering pins and also hinged to the rudder to insure alignment while the epoxy is drying.....Tandy

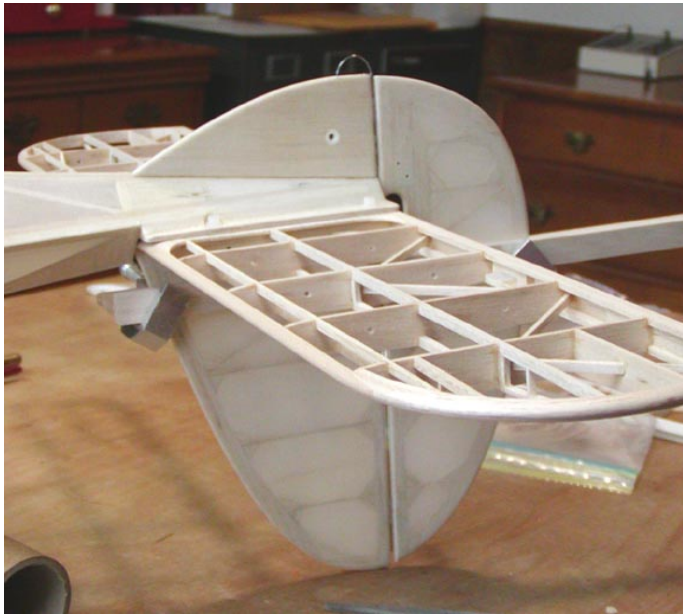
Sub Rudder Attachment-1.jpg

I thought I was being so careful installing the sub rudder on the Bomber only to discover I had the grain in the balsa of the sub rudder itself turned wrong#@\$%&. The grain should have been running vertical, but instead I had it running horizontal (see first picture below). The makes the sub rudder very weak and subject to being broke off.

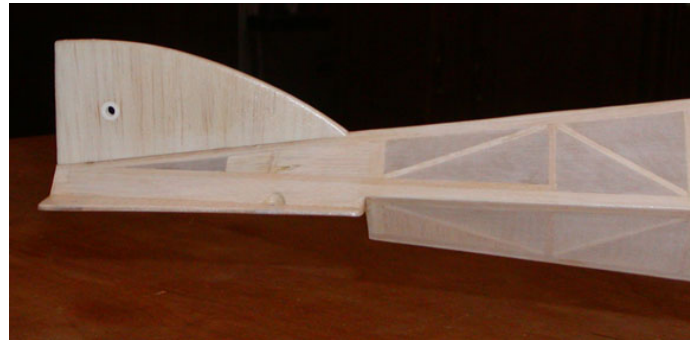
New Sub Rudder-1.jpg

So the day before yesterday morning, I removed the faulty sub rudder by cutting it off, leaving the centering pins in tact, and then carefully trimming and sanding down the bonded interface along the bottom longeron to make it smooth once again. During the past two days, I have made a completely new sub rudder with the grain running vertical as should be and doubled silk covered and doped it. This afternoon, I bonded the new correct sub rudder to

the fuselage one more time (see second picture below).....Tandy Walker.....

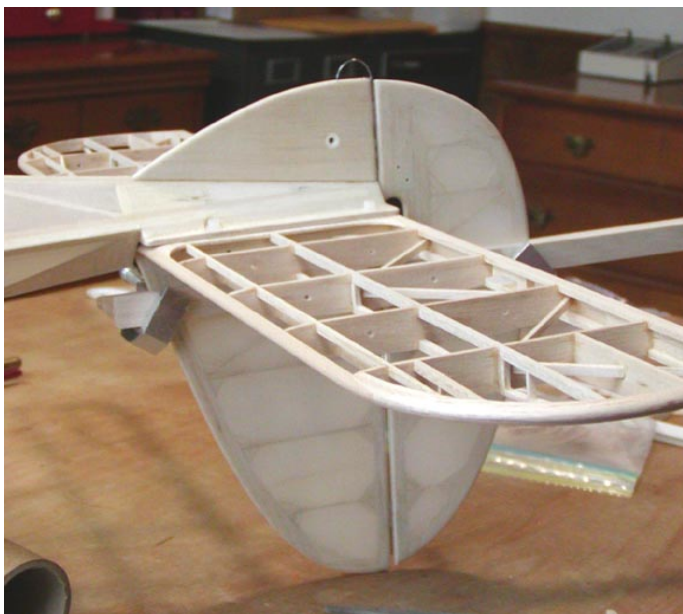
Sub Rudder Attachment-2.jpg

Here is a comparison of the two installed sub rudders. The first picture has the wrong grain orientation in the sub rudder and the second picture has the correct orientation. A lot of work for such a little change, but the sub rudder it is now as it should be!. Tandy Walker

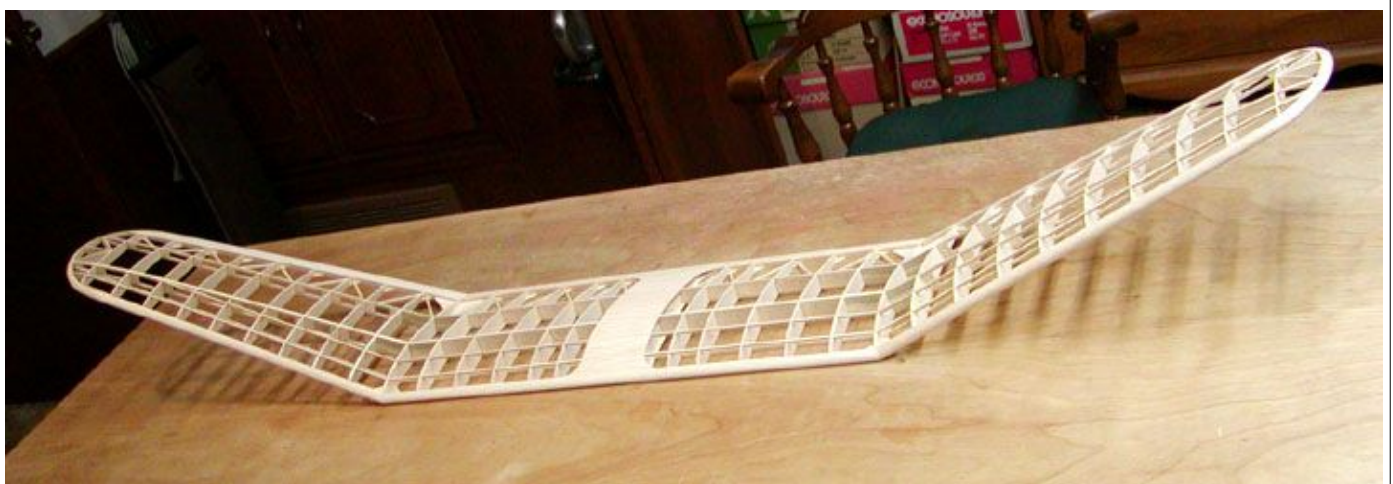
1Wing 1.jpg

(1) The first picture below is a recap of the detailed wing structure I last reported to you on.
(2) The second picture, taken essentially from the prospective, shows the covered wing.
(3) The third picture is a good planform shot of the covered wing. Note the small number "39" out on the right wing tip. This is channel number of the radio frequency used in this aircraft.

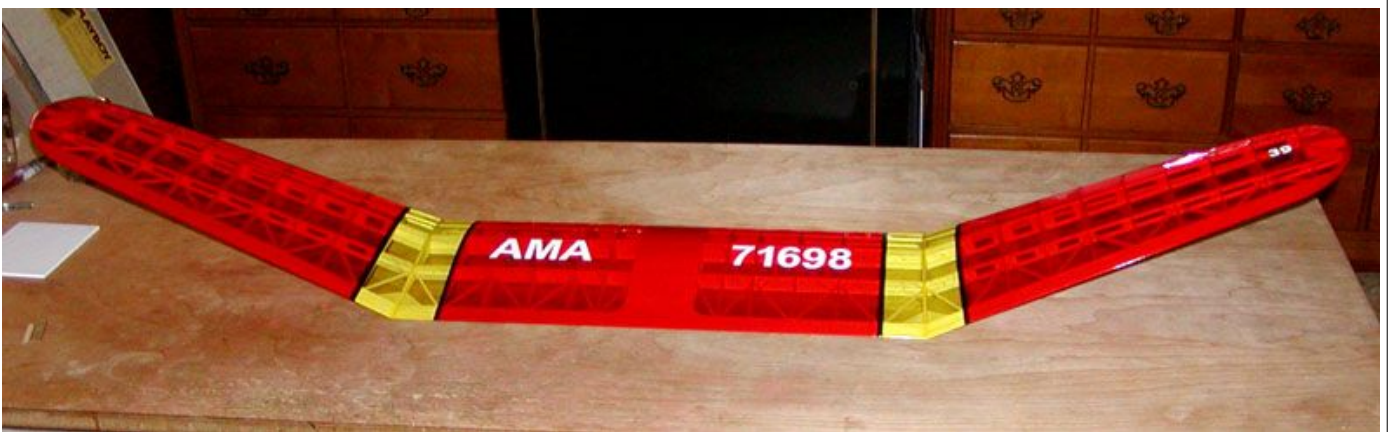
Wing Covered 3.jpg

(4) I included the fourth picture to show the changing spanwise shear web pattern of both the front and rear spars.

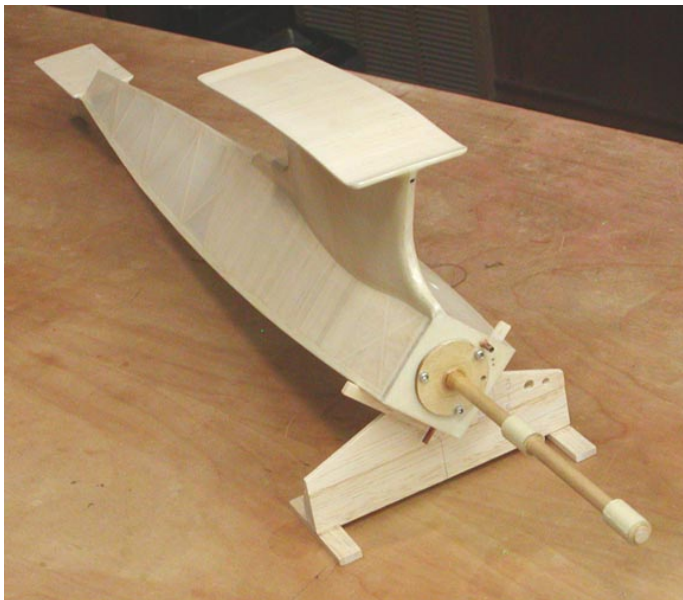
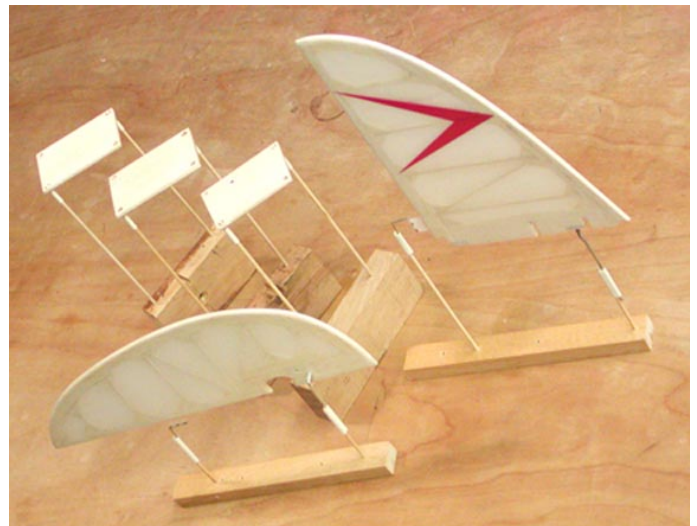
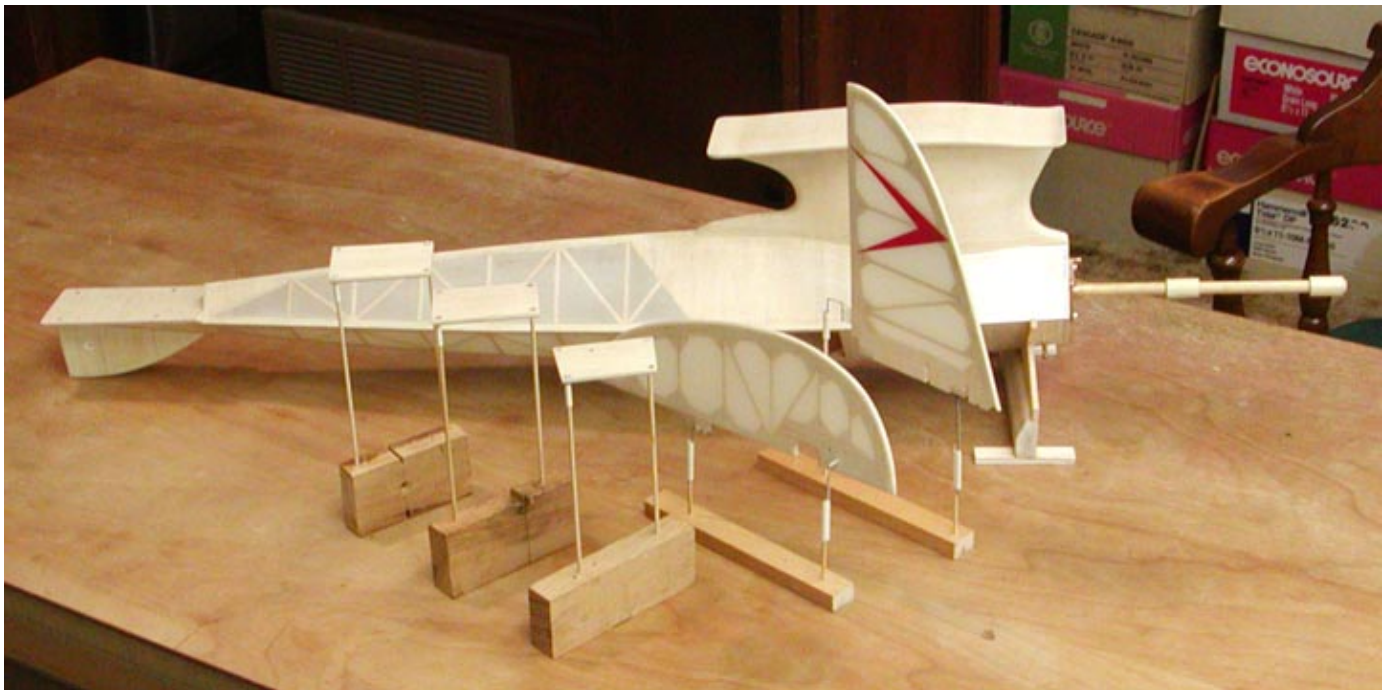
I have spent the morning making paint stands (or fixtures) to hold the fuselage, three access hatches, fin, and rudder while I airbrush a thin fuel proof top coat on them. See pictures below. Once painted, the parts can be sat aside to dry overnight in these fixtures.....

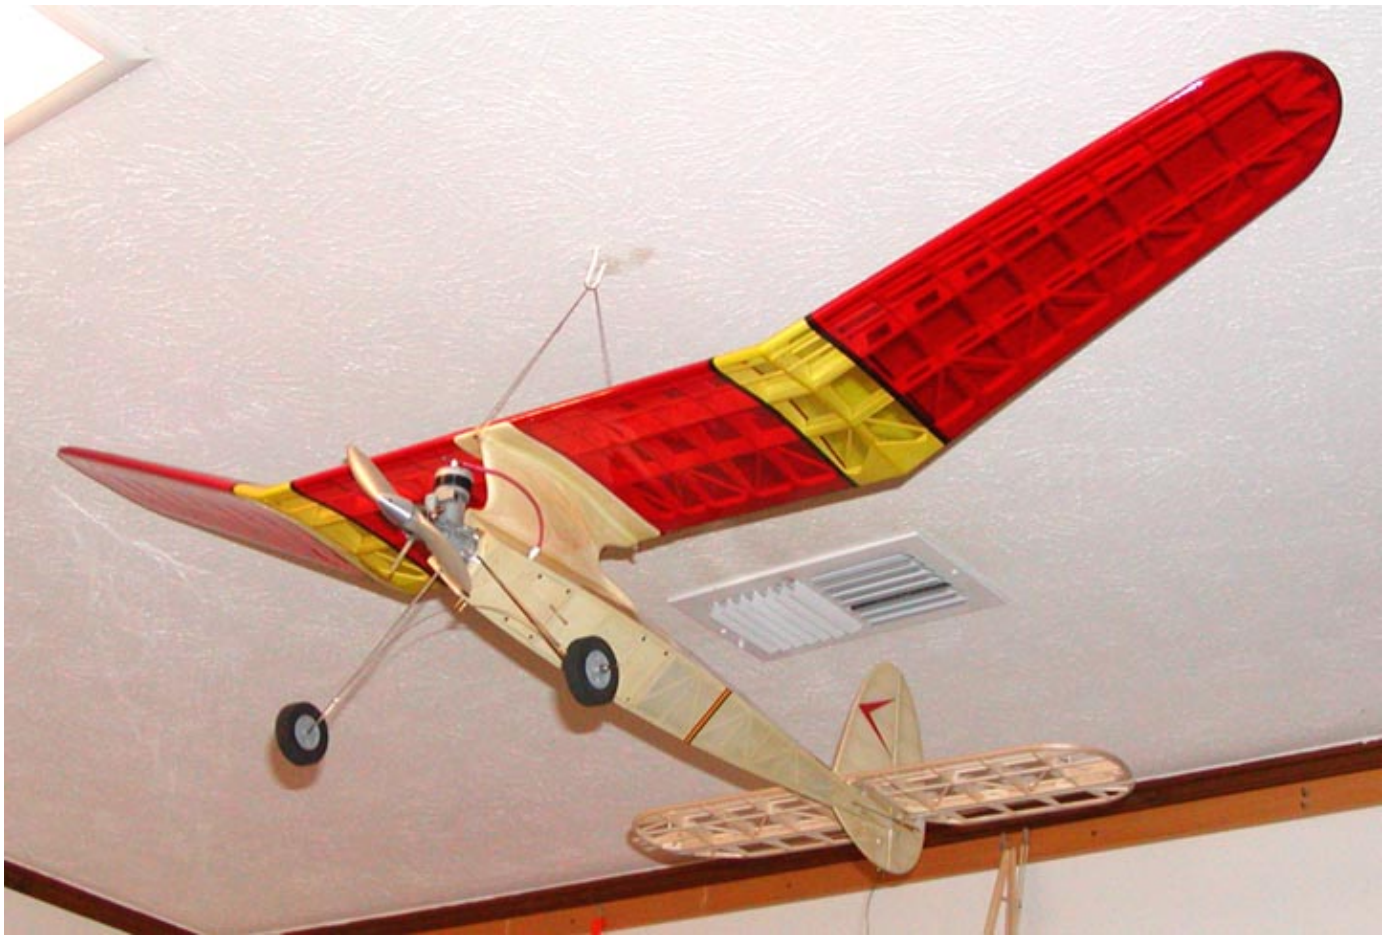
Bomber 1.jpg

Since the air brushed coat of Hobby Poxy on the fuselage, fin, and rudder has thoroughly dried during the last several days, I decided to do a trial assembly on the Class A Bomber today (see attached picture) to check the weight and balance. The only thing missing is the covering of the stab and elevator. I first weighed the Bomber with the 270 mah 40 gram NiCad ignition battery pack on my Acculab scales at 760 grams (26.81 ounces). Then I checked the C.G. and it was right on the desired 50% balance point, without the covering on the stab and elevator of course.

The wing area was calculated to be 415.55 sq. in. from the scaled plans, so for the required minimum 10 ounce wing loading, it must weigh at least $(10 \times 414.55/144) = 28.79$ ounces. Therefore, the ship is 1.98 ounces underweight! I purchased a light weight 340 mah 9 gram Li-Po Lithium battery for use on the ignition system instead of the NiCad pack, but the model is already too light and will be slightly tail heavy with the addition of the covering on the stab and elevator, so I will not use it after all.

I will add the appropriate amount of lead inside the engine's back plate and radial mount to trim the weight and C.G. at 28.8 ounces and 50%, respectively. So now I will disassemble the Bomber, cover the stab and elevator over the next day or so, and reassemble the model. Before installing the engine, it has to be bench mounted and broke-in as it is a NIB Shilen Old Timer .19.
